LOCATION		YEAR	
Guatemala		PROFESIONAL SERVICES	CONSTRUCTION (If applicable)
		2005	2005
PROJECT OWNER INFORMATION			
a. PROJECT OWNER	b. CONTACT NAME	c. CONTACT PHONE NUMBER	
Maritime Claims Americas, Inc.	Lic. Fernando Lorenzana	+502-2368-2673	
PROJECT REPORT (Reach, Size and Cost)

Project Background – On November 17 2004 the Silver Clipper ship collided with the No 3 Pier structure on Santo Tomas de Castilla Port causing its partial destruction. Our company was hired by Maritime Claims Americas Inc. to do an evaluation and repair the dock to its original shape.

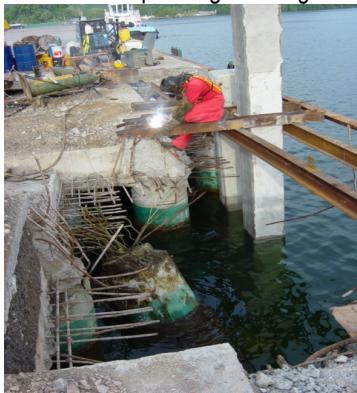
Damage Evaluation - Damage evaluation did include a complete evaluation of the damage for the reconstruction planning including submarine structures.

Submarine Demolition – The submarine demolition required special equipment and specialized personnel including divers and hydraulic jaws, during this process a safety plan was executed and special measures were taken for the preservation of submarine life.

Piles Ramming - For the reconstruction 9 concrete piles were lamed into submarine soil using a diesel hammer mounted on tracks.

Concrete Structures - Floor, beams, bollards and defense anchorages were reconstructed to its original design specifications using specified materials (steel, steel coatings, concrete and concrete additives).

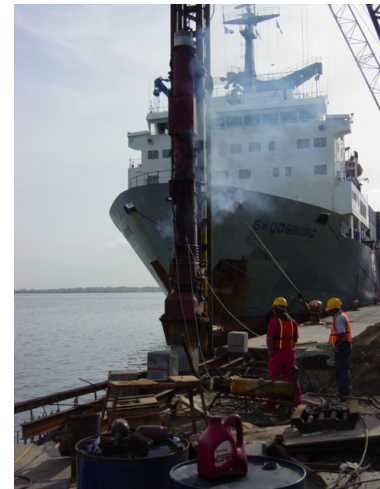
Project Key Elements
➤ Damage Evaluation
➤ Submarine Demolition
➤ Concrete Structures
➤ Rammed Piles
